Blue Mountain Forest Health Observations:

Blue Mountain Forest Health Map

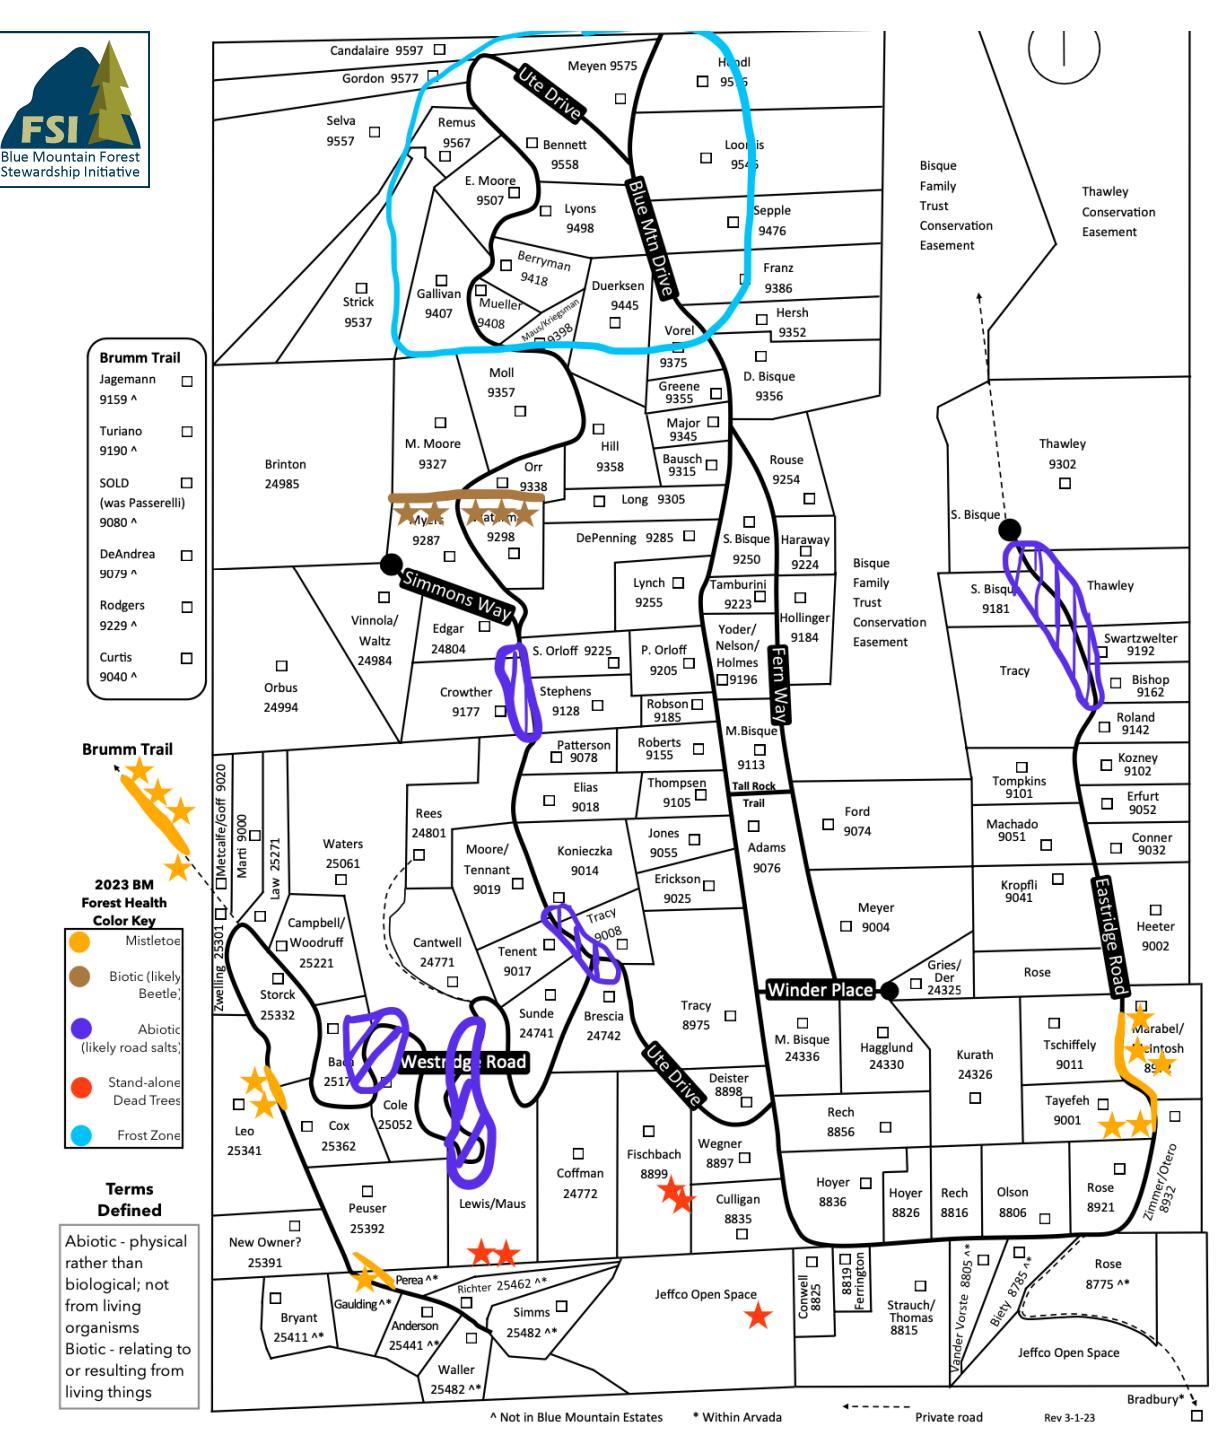
Westridge Road: Several dead trees - evidence of long-term Ponderosa mistletoe infestations

Westridge Road: Several brown and dead trees - Abiotic - suspect continued exposure to road salt is the primary concern

Ute Drive: Brown and dead trees - Abiotic near road - possible Ips Beetle mortality on larger trees off the road -no evidence of Mtn Pine Beetle)

Lower Valley: Multiple brown trees - often on the north side - possible needle damage from frost monitor for new buds (frost should not have killed the buds nor trees). Several trees are non-native pines which are susceptible to frost damage.

Eastridge Road: Several dead trees - evidence of long-term Ponderosa mistletoe infestations.

North end of Eastridge Road - Several brown and dead trees - Abiotic - continued exposure to road salt is primary concern.

Several stand alone dead trees as shown on the map should be inspected by homeowner for Mountain Pine Beetle pitch tubes. (See reverse for pictures on how to identify). Thus far, none of the trees inspected have had pitch tubes; likely other causes of illness/death.

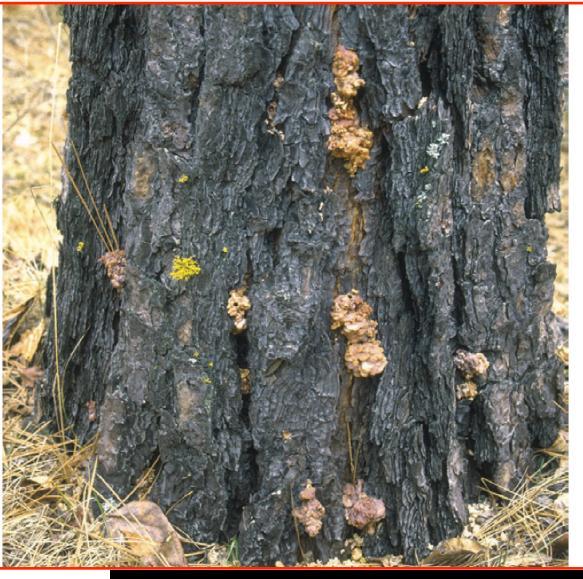
Photo: Kenneth E. Gibson, USDA Forest Service, Bugwood.org

Mountain Pine Beetle

The mountain pine beetle is the most aggressive, persistent, and destructive bark beetle in the western United States and Canada. This is one of the few bark beetles that typically make obvious pitch tubes on bark surface at the attack site. Pitch tubes are masses of red, amorphous resin mixed with bark and wood borings. Boring dust is evident in bark crevices and around the base of infested trees.
